**MEMORANDUM**

TO: Hazardous Waste Enforcement File  
Green America Recycling, LLC  
Hannibal, Ralls County, MO  
EPA ID # MOD054018288

SUBJECT: Site Visit – Green America Recycling, LLC  
10107 Hwy 79  
Hannibal, MO 63401

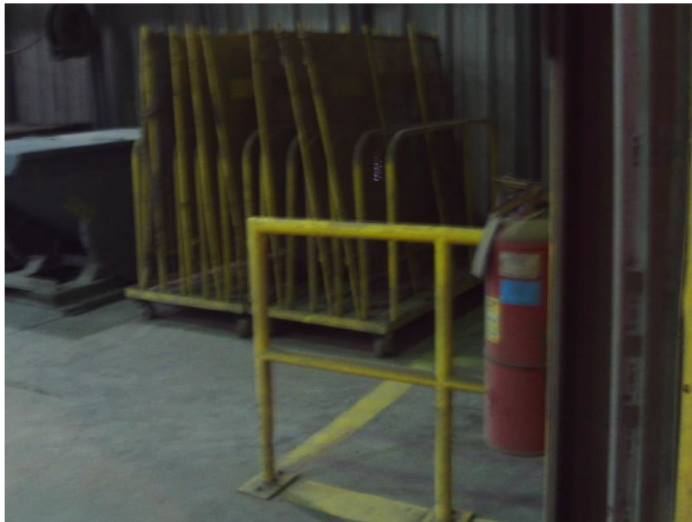
**Photograph: # 2.**  
**Taken By:** Cheyenne Bure  
**Date Taken:** March 11, 2020  
**Program:** Waste Management

**Entity:** Green America Recycling, LLC  
**Permit:** MOD054018288  
**Location:** CSA #4  
**Description:** Fire extinguisher located on southern wall of CSA #4.

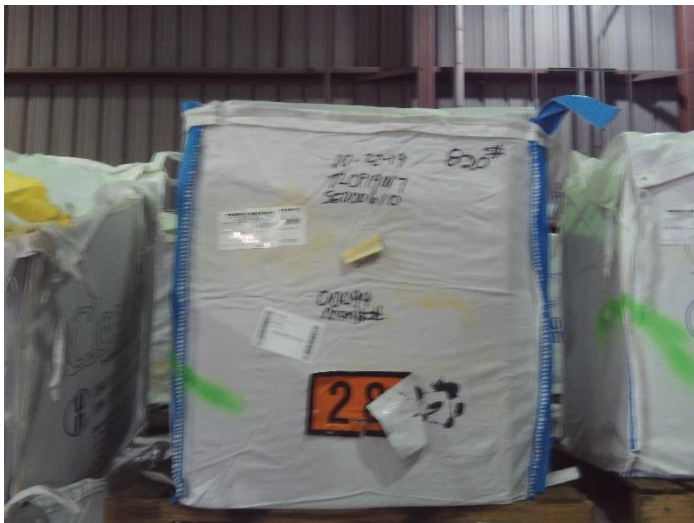
**Photograph: # 10.**  
**Taken By:** Nicole Eby  
**Date Taken:** March 11, 2020  
**Program:** Waste Management

**Entity:** Green America Recycling, LLC  
**Permit:** MOD054018288  
**Location:** CSA #4  
**Description:** Cubic yard containers in storage.

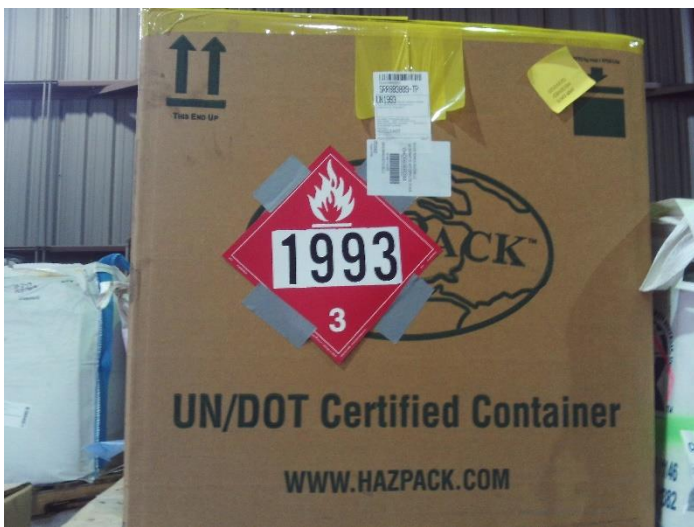
**Photograph: # 11.**  
**Taken By:** Nicole Eby  
**Date Taken:** March 11, 2020  
**Program:** Waste Management

**Entity:** Green America Recycling, LLC  
**Permit:** MOD054018288  
**Location:** CSA #4  
**Description:** Cubic yard containers in storage.

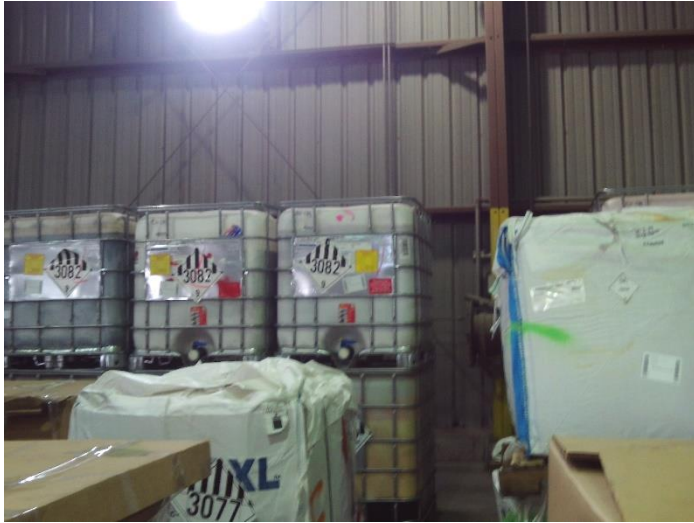
**Photograph: # 12.**  
**Taken By:** Nicole Eby  
**Date Taken:** March 11, 2020  
**Program:** Waste Management

**Entity:** Green America Recycling, LLC  
**Permit:** MOD054018288  
**Location:** CSA #4  
**Description:** Cubic yard containers and totes in storage.

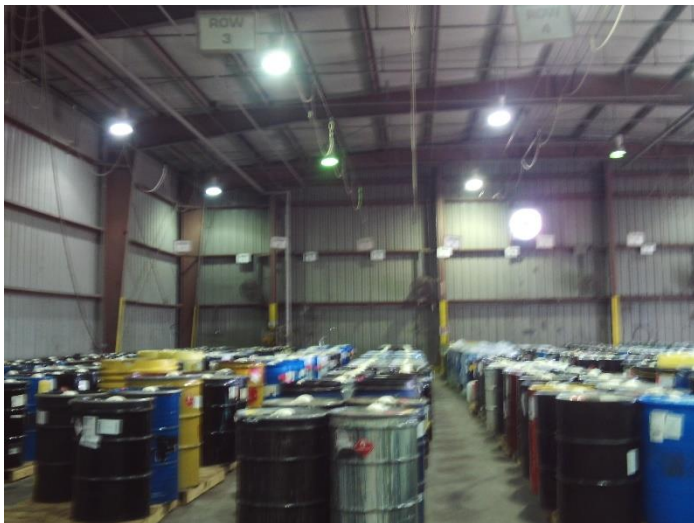
**Photograph: # 13.**  
**Taken By:** Nicole Eby  
**Date Taken:** March 11, 2020  
**Program:** Waste Management

**Entity:** Green America Recycling, LLC  
**Permit:** MOD054018288  
**Location:** CSA #4  
**Description:** Hazardous waste drums in storage. Looking north.

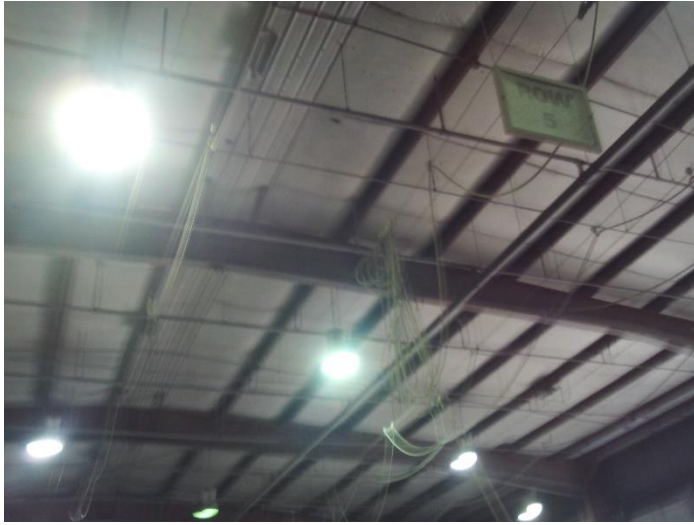
**Photograph: # 15.**  
**Taken By:** Nicole Eby  
**Date Taken:** March 11, 2020  
**Program:** Waste Management

**Entity:** Green America Recycling, LLC  
**Permit:** MOD054018288  
**Location:** CSA #4  
**Description:** Fire suppression pipes suspended from ceiling.

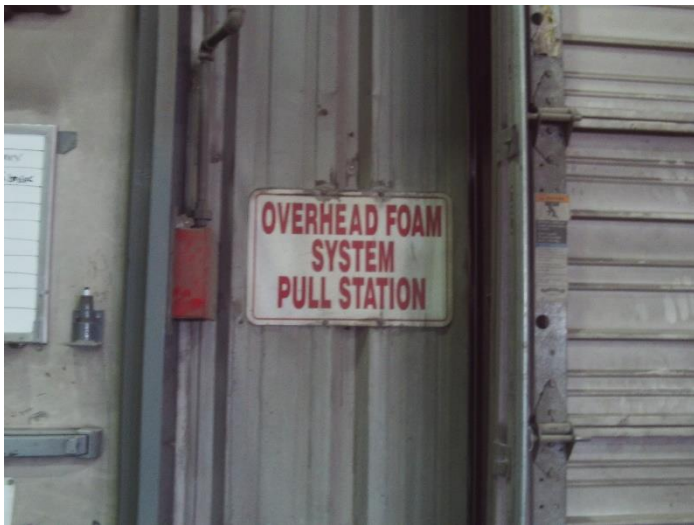
**Photograph: # 16.**  
**Taken By:** Nicole Eby  
**Date Taken:** March 11, 2020  
**Program:** Waste Management

**Entity:** Green America Recycling, LLC  
**Permit:** MOD054018288  
**Location:** CSA #4  
**Description:** Fire suppression system sign on west wall.

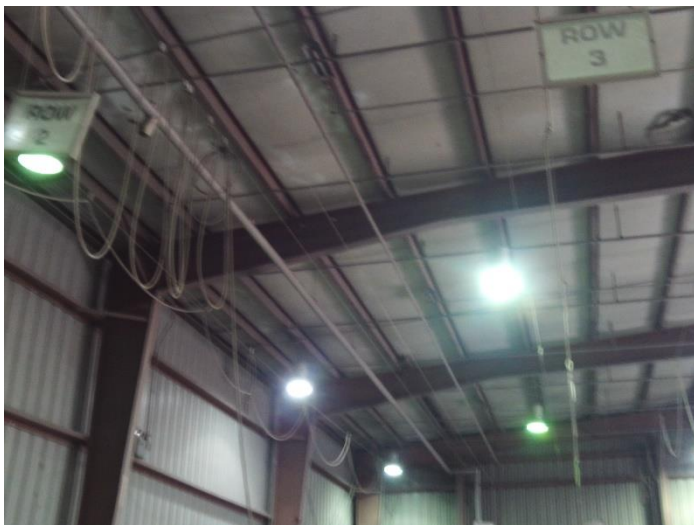
**Photograph: # 17.**  
**Taken By:** Nicole Eby  
**Date Taken:** March 11, 2020  
**Program:** Waste Management

**Entity:** Green America Recycling, LLC  
**Permit:** MOD054018288  
**Location:** CSA #4  
**Description:** Fire suppression system is suspended on ceiling. Looking north.

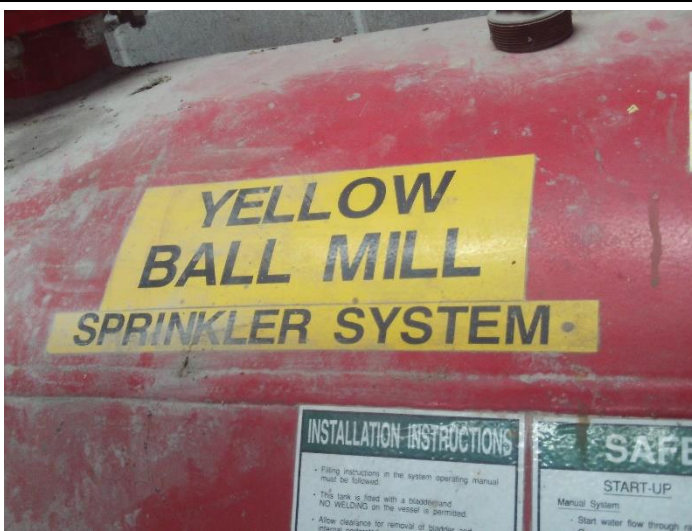
**Photograph: # 20.**  
**Taken By:** Nicole Eby  
**Date Taken:** March 11, 2020  
**Program:** Waste Management

**Entity:** Green America Recycling, LLC  
**Permit:** MOD054018288  
**Location:** Fire house #1  
**Description:** Signage on the ball mill sprinkler system in Fire House #1

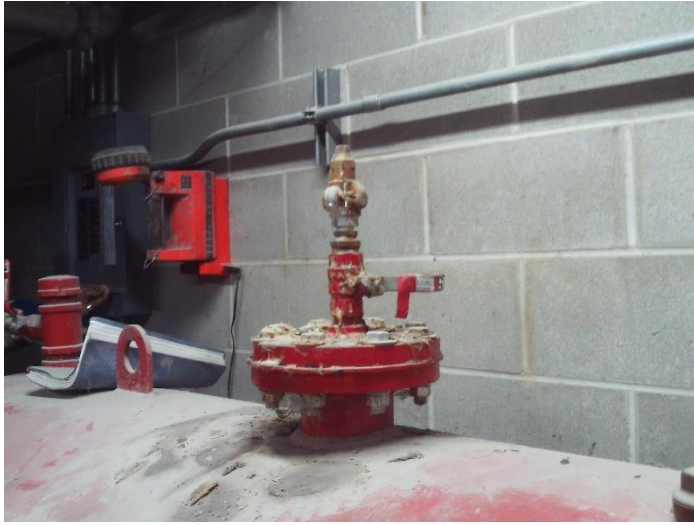
**Photograph: # 21.**  
**Taken By:** Nicole Eby  
**Date Taken:** March 11, 2020  
**Program:** Waste Management

**Entity:** Green America Recycling, LLC  
**Permit:** MOD054018288  
**Location:** Fire house #1  
**Description:** Fuse box and fire suppression system components sin Fire House #1

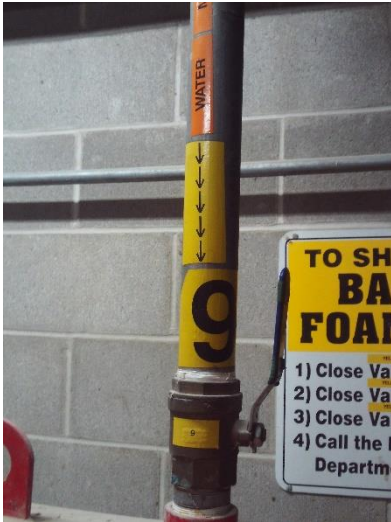
**Photograph: # 22.**  
**Taken By:** Nicole Eby  
**Date Taken:** March 11, 2020  
**Program:** Waste Management

**Entity:** Green America Recycling, LLC  
**Permit:** MOD054018288  
**Location:** Fire house #1  
**Description:** Water line to Ball Mill Foam suppression system in Fire House #1

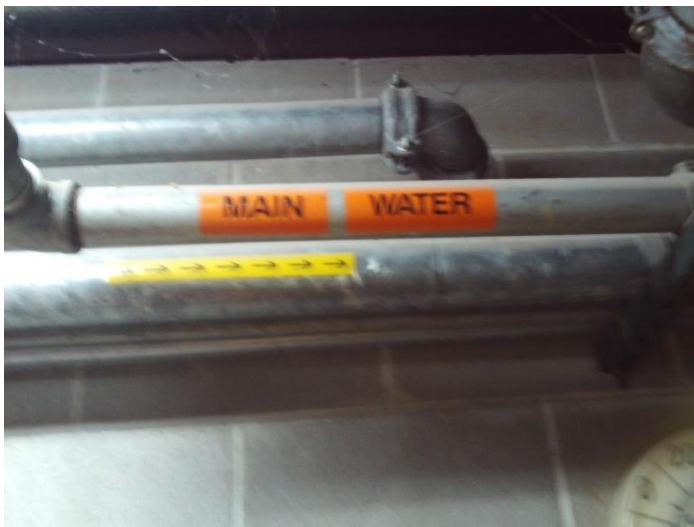
**Photograph: # 23.**  
**Taken By:** Nicole Eby  
**Date Taken:** March 11, 2020  
**Program:** Waste Management

**Entity:** Green America Recycling, LLC  
**Permit:** MOD054018288  
**Location:** Fire house #1  
**Description:** Additional piping in Fire House #1

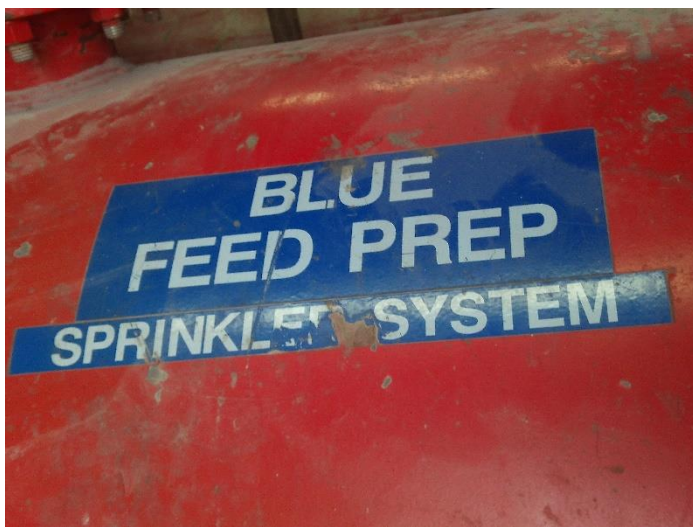
**Photograph:** # 26.  
**Taken By:** Nicole Eby  
**Date Taken:** March 11, 2020  
**Program:** Waste Management

**Entity:** Green America Recycling, LLC  
**Permit:** MOD054018288  
**Location:** Fire house #1  
**Description:** Signage on the Feed Prep sprinkler system in Fire House #1

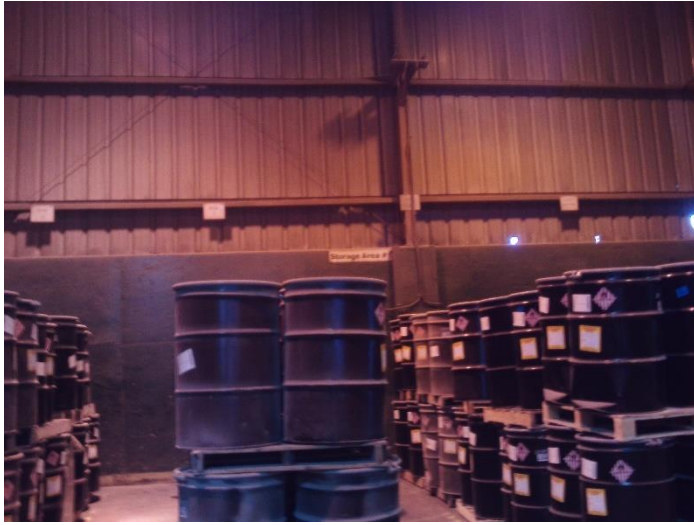
**Photograph: # 29.**

**Description:** Drums in storage in CSA #1

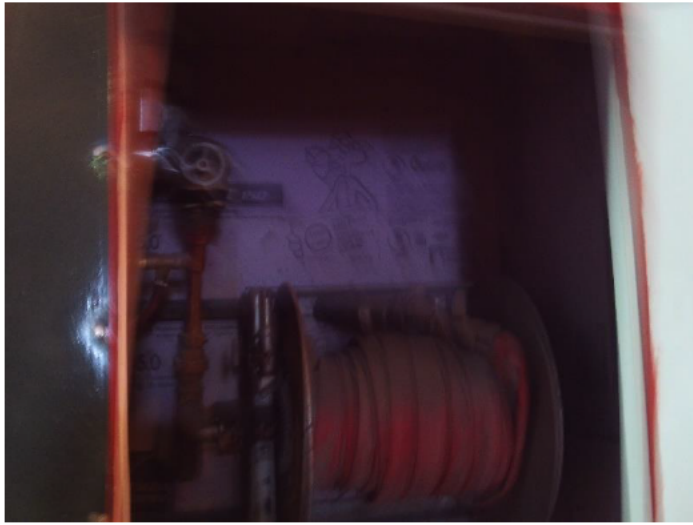
**Photograph: # 32.**  
**Taken By:** Nicole Eby  
**Date Taken:** March 11, 2020  
**Program:** Waste Management

**Entity:** Green America Recycling, LLC  
**Permit:** MOD054018288  
**Location:** CSA #1  
**Description:** View of fire suppression equipment on southwest wall.
